GRACIELA
AINSWORTH

2nd November 2018

**FINAL CONSERVATION REPORT FOR THE MARBLE
ROBERT BURNS STATUE IN DUMFRIES TOWN CENTRE**

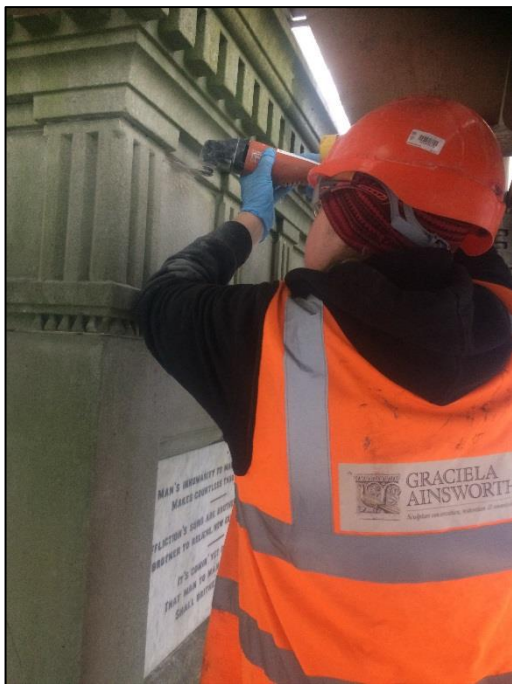
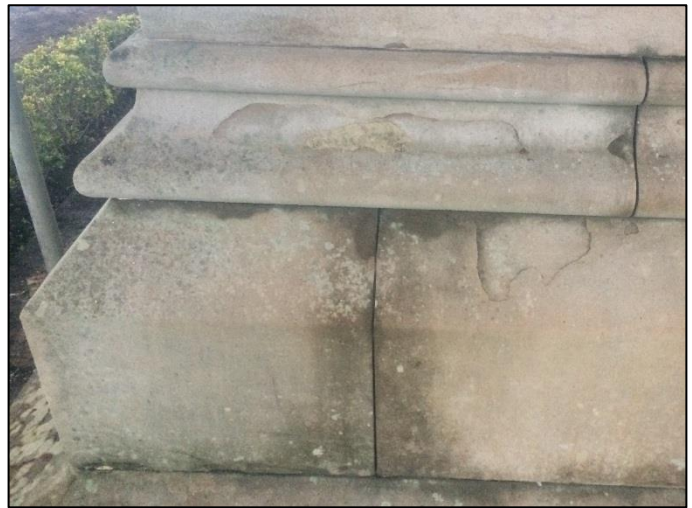
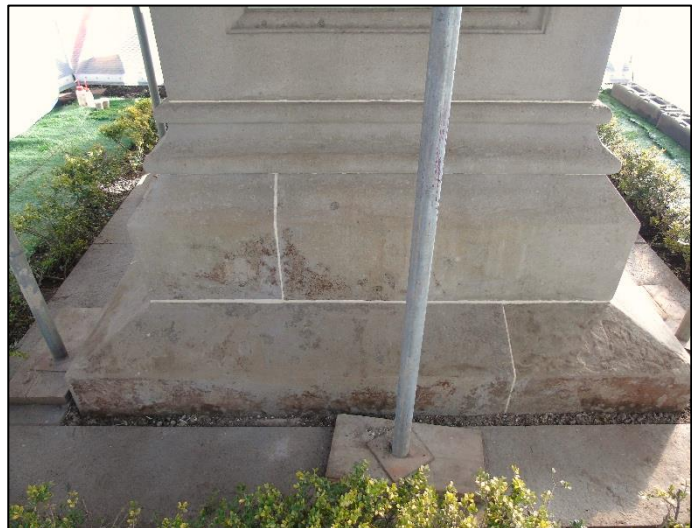
Above: Raking out failed mortar with an oscillating tool

Above Right: Joints in the lower courses of the plinth raked out and cleaned

Right: Joints in the lower courses re-pointed

- All joints except for those surrounding the marble inscription panels were carefully raked out using fine tungsten chisels, and for the hardest joints an oscillating tool was used where necessary. The joints surrounding the marble inscription panels were inspected after cleaning and on balance it was decided not to re-point at this time. The mortar was sound structurally and its removal would have risked damage to the marble.
- Following raking out the joints were cleaned with water to remove mortar debris and re-pointed with lime mortar: '120 Ashlar Mix' containing linseed oil, specifically designed for use in fine joints. The joint at the base of the sculpture between the marble and the sandstone was pointed with a lime-based repair mortar, slightly stronger than the Ashlar Mix to give this more vulnerable joint greater longevity.

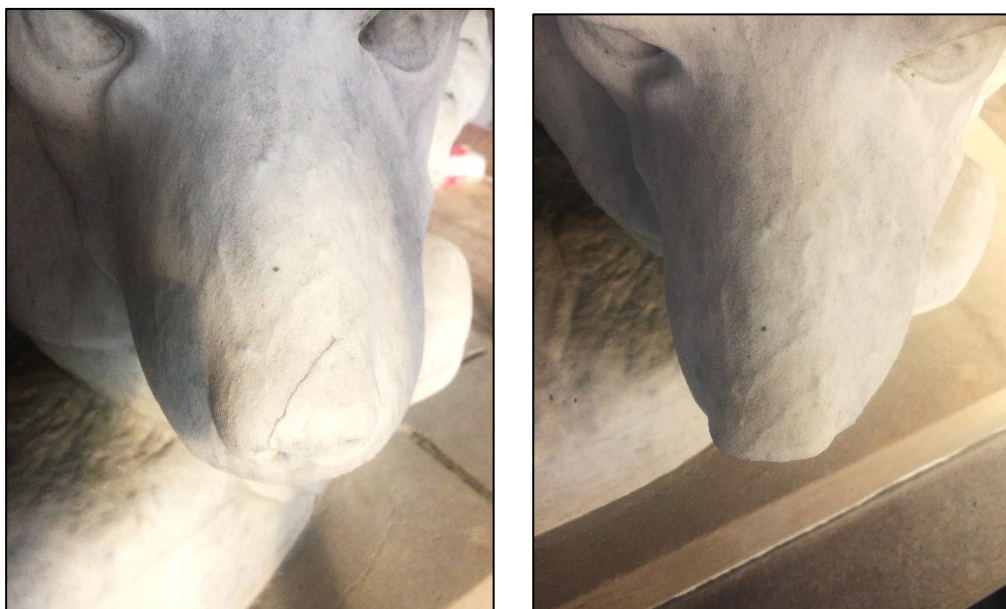
Crack in the dog's nose before (left) and after (right) Paraloid B72 repair

- The most vulnerable areas of scaling, surface loss and cracking to the marble sculpture and the sandstone base were consolidated and filled as required to prevent further water pooling and ingress. Localized consolidation was completed with Paraloid B72 6% in acetone.

- Fine fills to cracks and pits in the sculpture were completed using Paraloid B72 10% in acetone with marble dust and natural earth pigments, and the visible deep channels in the marble panels were filled with the same to deter further deterioration from dripping water.

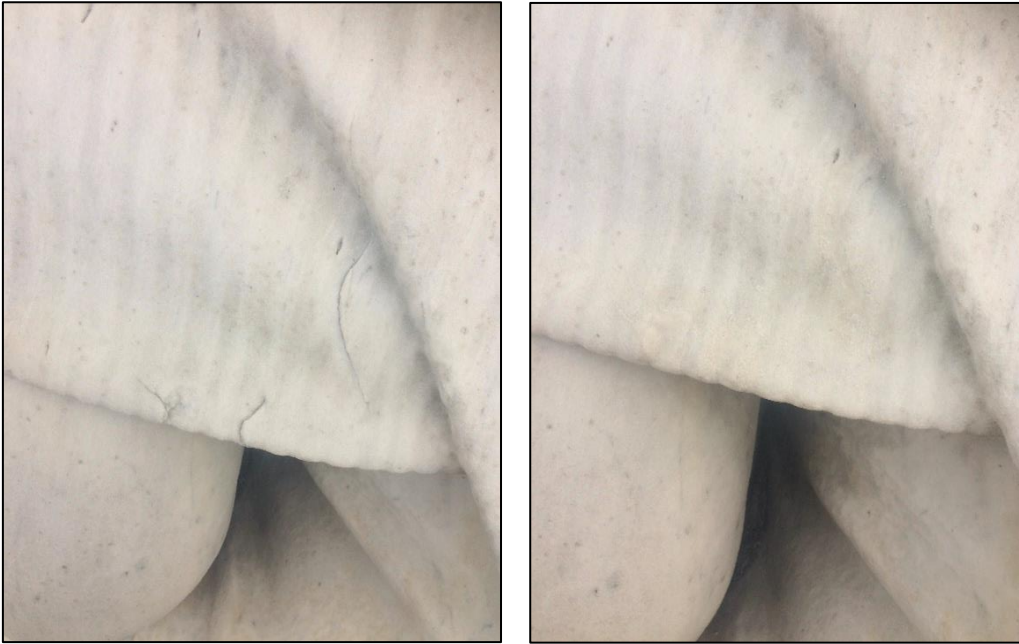
Cracks in the fly plaid before (left) and after (right) Paraloid B72 repair

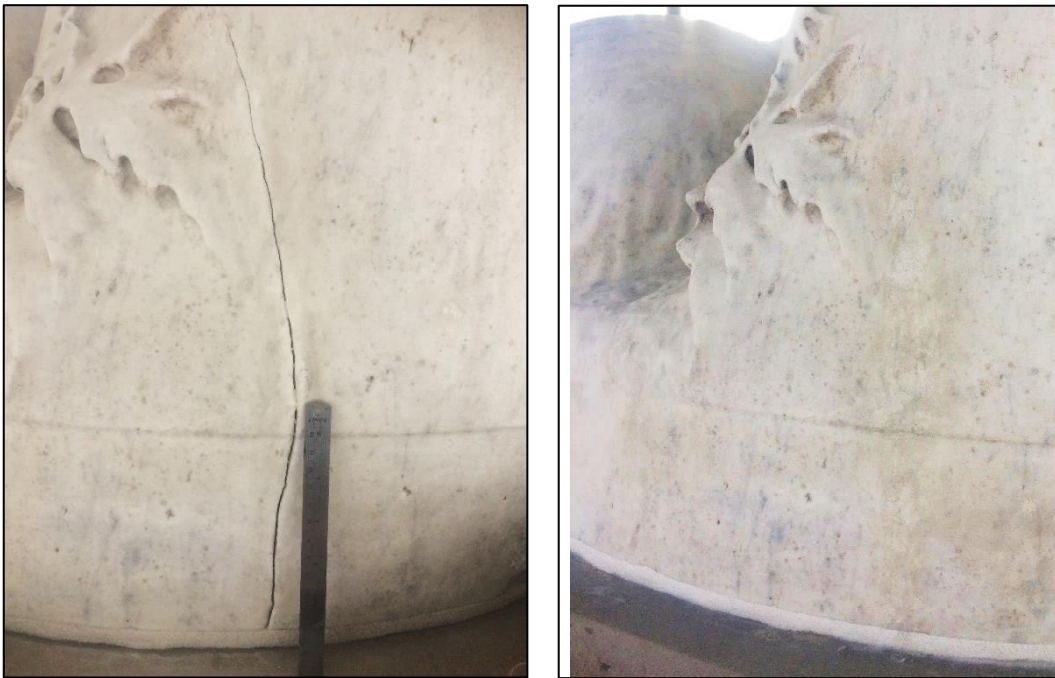
Long crack adjacent to the thistle before (left) and after (right) Paraloid B72 repair

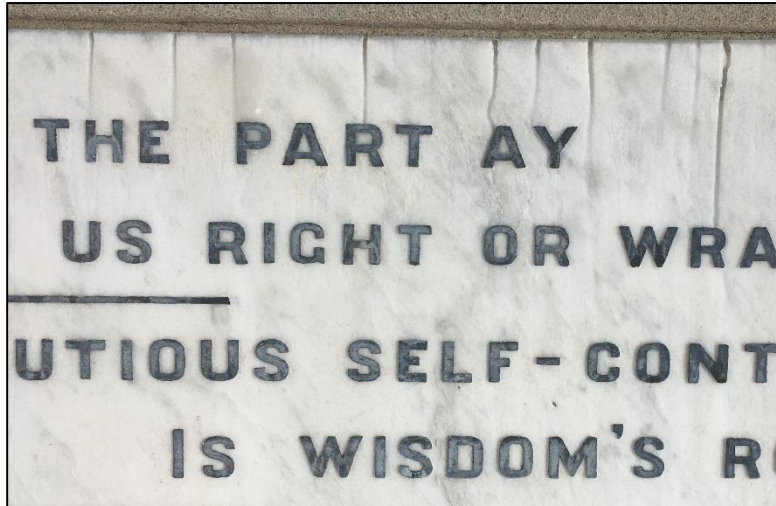
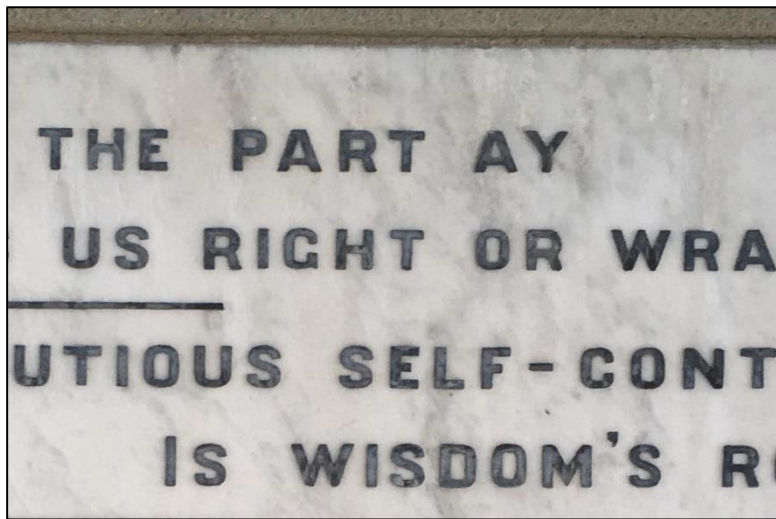
*Channels in marble panel
before (above) after
(below) Paraloid B72
repair*

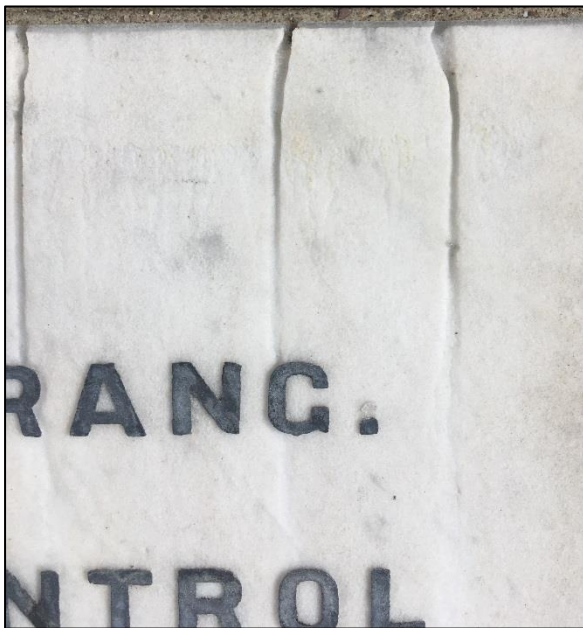
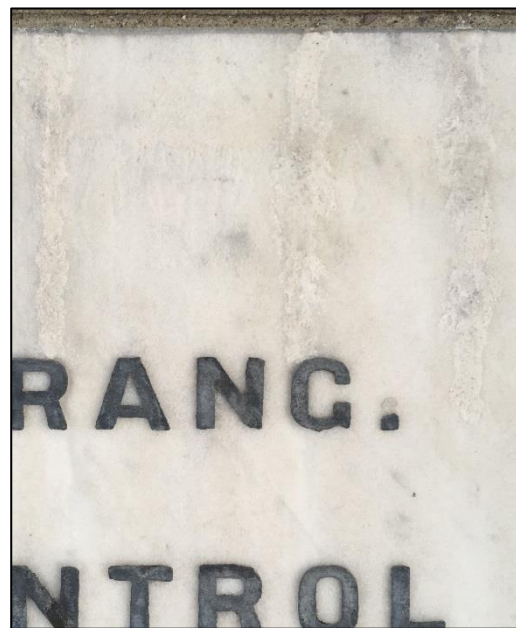
*Channels in marble before (left) after (right)
Paraloid B72 repair*

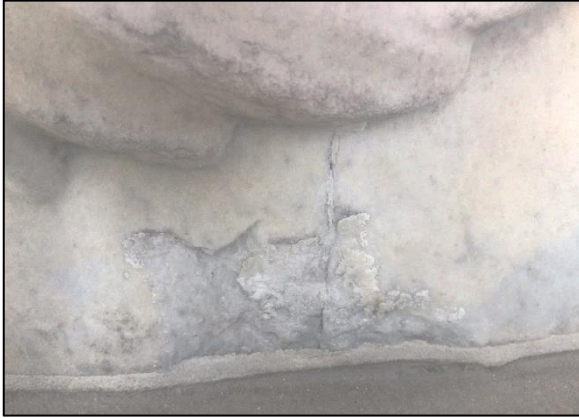
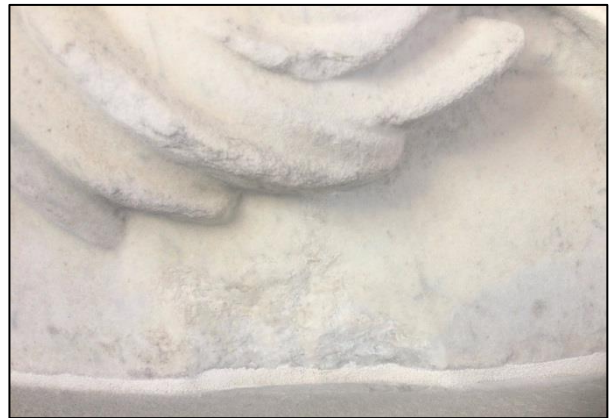
Crack and surface loss below foliage before (left) and after (right) Paraloid B72 repair

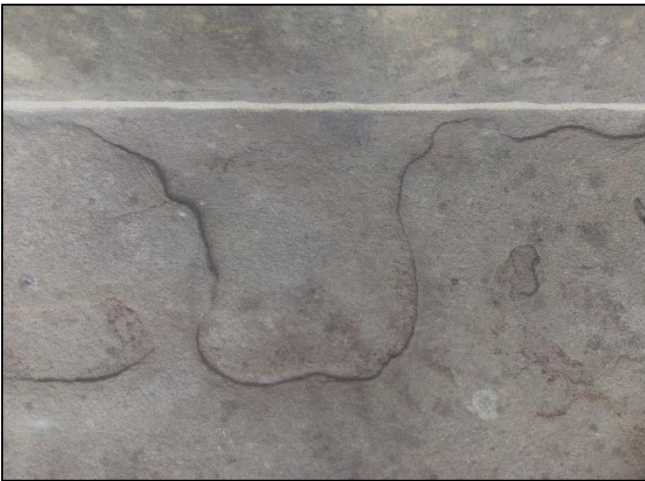
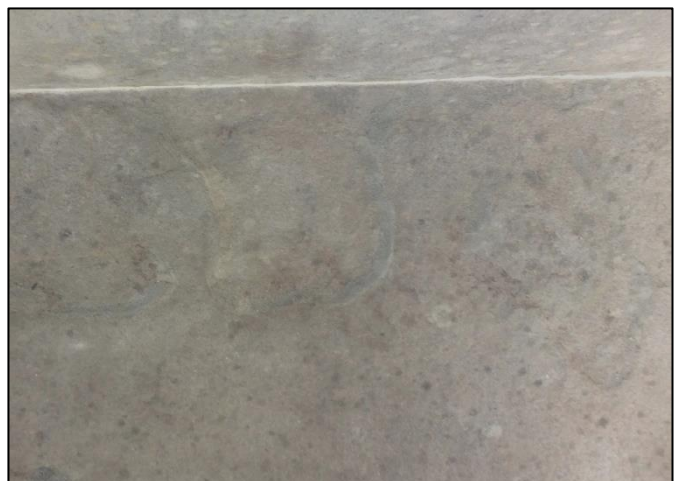
Cracks in lowest course of the plinth before (left) and after (right) Paraloid B72 repair

- Fine fills and capping to cracks and laminations in the sandstone were completed with Paraloid B72 10% in acetone with fine sands and natural earth pigments to deter water penetration.

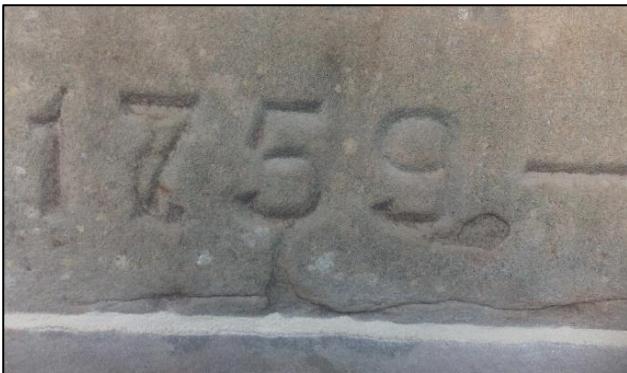
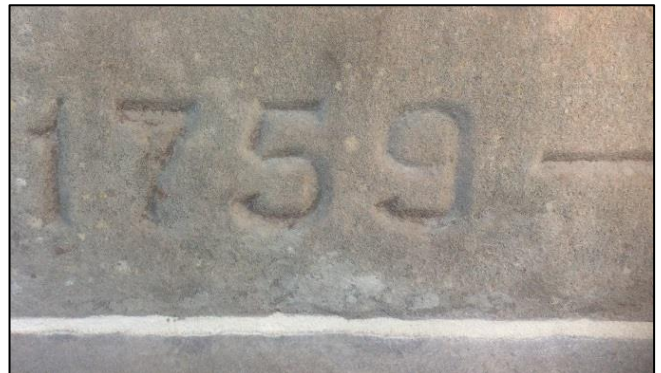
Cracks below the date inscription of before (left) and after (right) Paraloid B72 repair

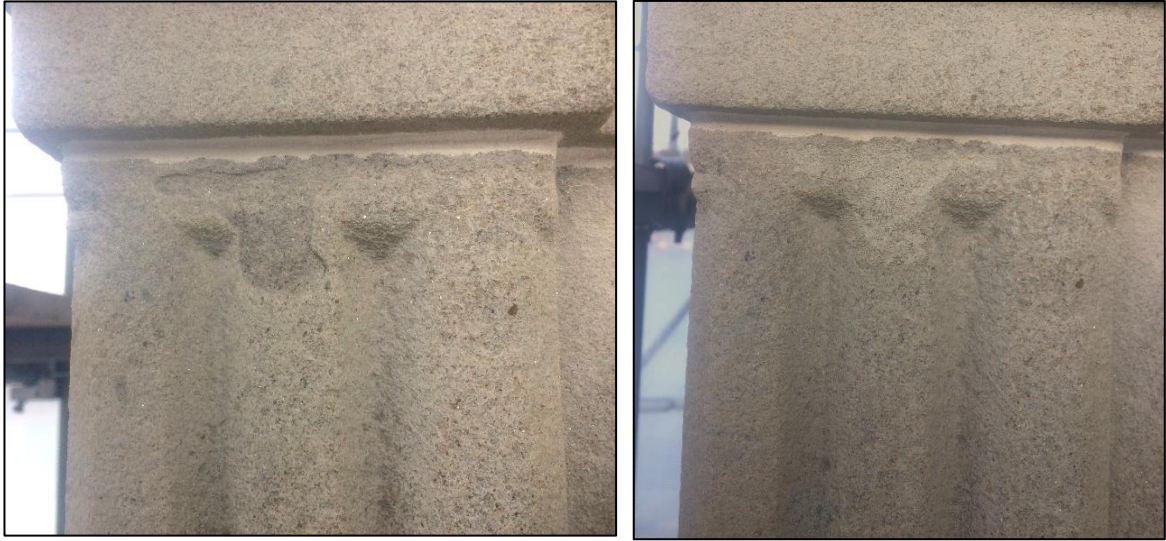
Surface scaling to triglyph moulding before (left) and after (right) Paraloid B72 repair

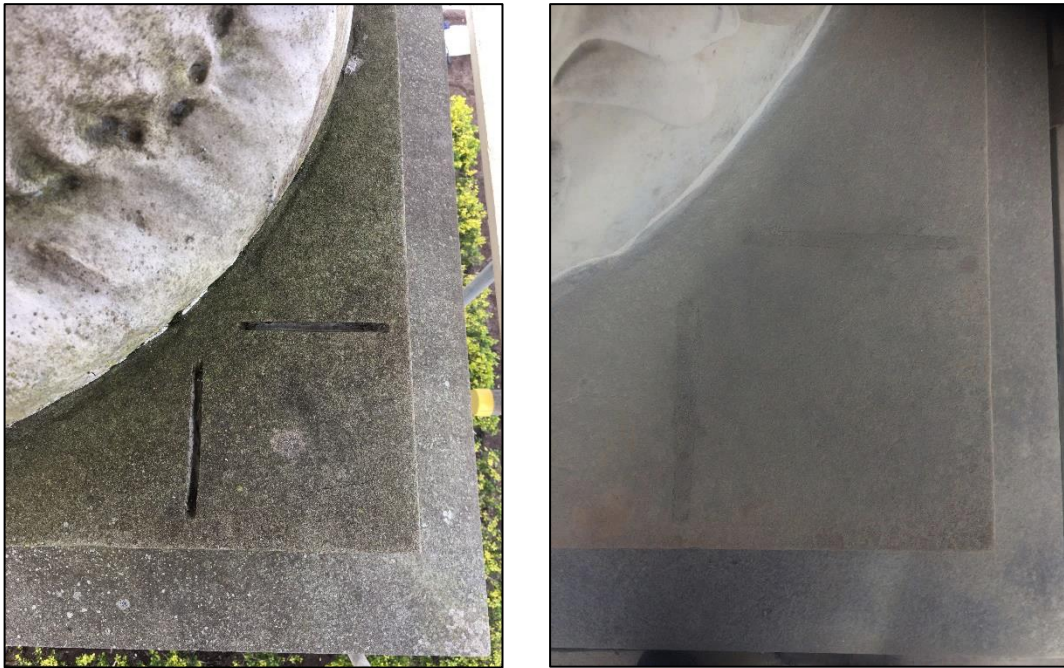
- During conservation works 8 no. metal cramps set into channels were discovered in the top of the sandstone plinth. They were not previously visible during the condition survey taken from ground level. They would have been put in during prior conservation works to halt the progression of a circular crack running around the base of the marble statue. The cramps were in a stable condition but resin fills protecting them had deteriorated. The fills were therefore topped up with polyester resin and a final layer of Paraloid B72 10% in acetone with fine sands and natural earth pigments.

Metal cramps set into channels at the top of the sandstone plinth before (left) and after (right) polyester resin and Paraloid B72 repair

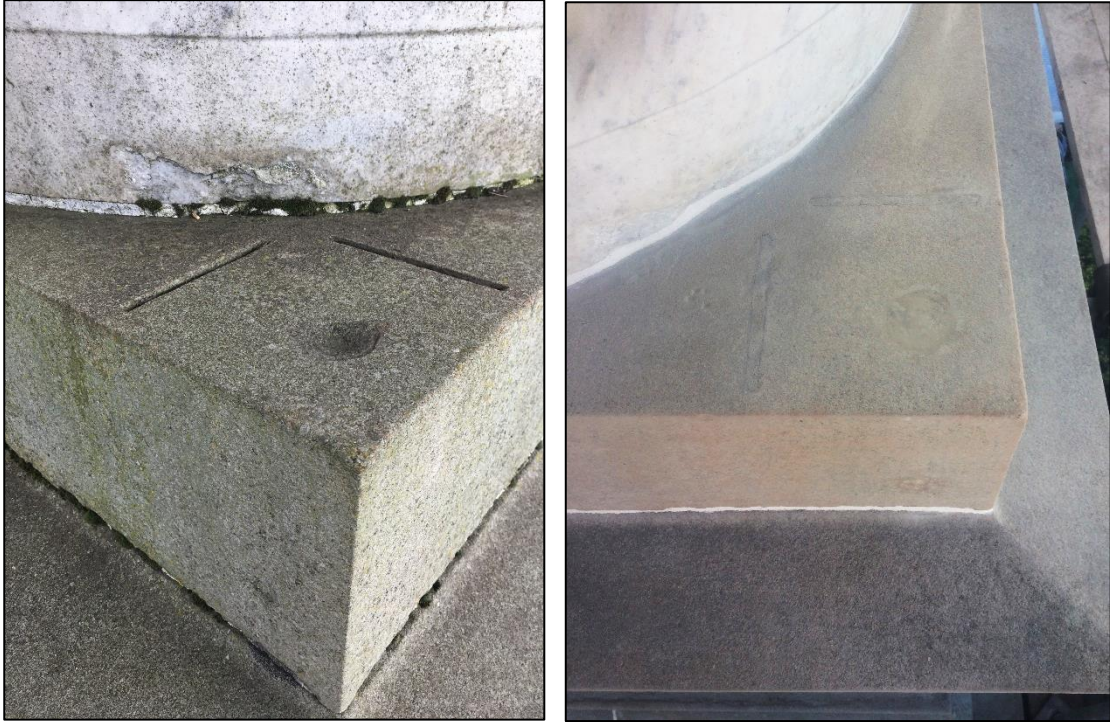
Metal cramps set into channels at the top of the sandstone plinth before (left) and after (right) polyester resin and Paraloid B72 repair. Circular loss before (left) and after (right) Paraloid B72 repair

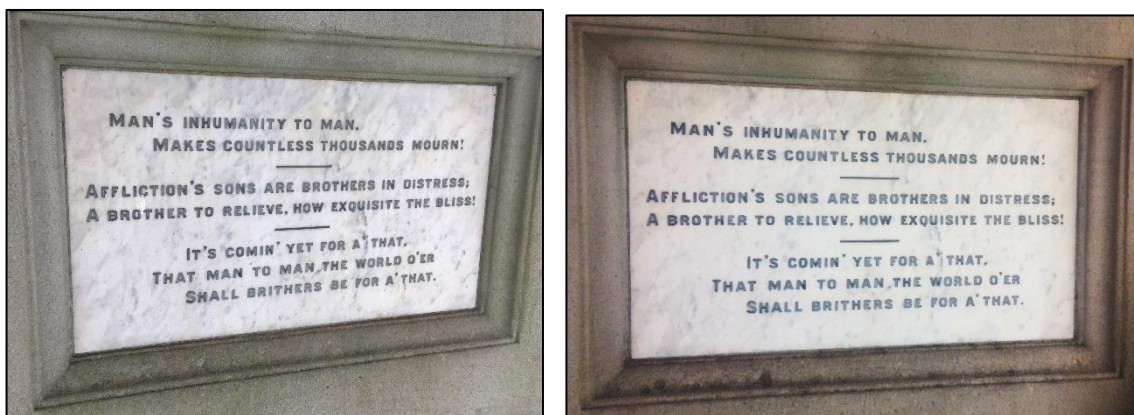
- The lead lettering was cleaned with water and nylon brushes during the cleaning of the marble inscription panels. After cleaning the letters were inspected and on balance it was decided not to treat them at this time. The lead was structurally sound and the inscriptions readable, and application of paint would add to future maintenance.

Left: marble inscription panel before cleaning. Right: marble inscription panel after cleaning

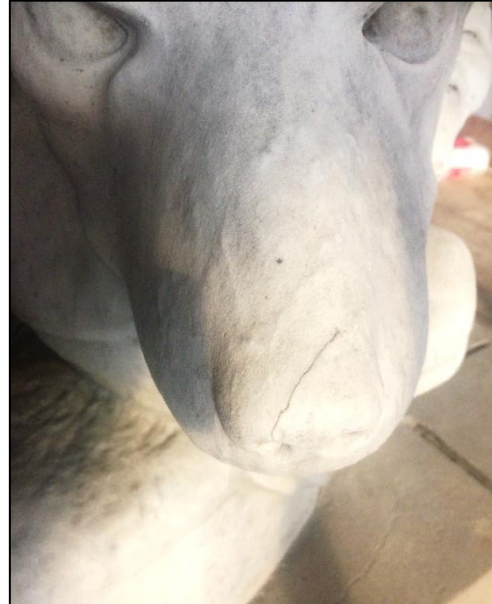
Across the dog's nose: 40mm

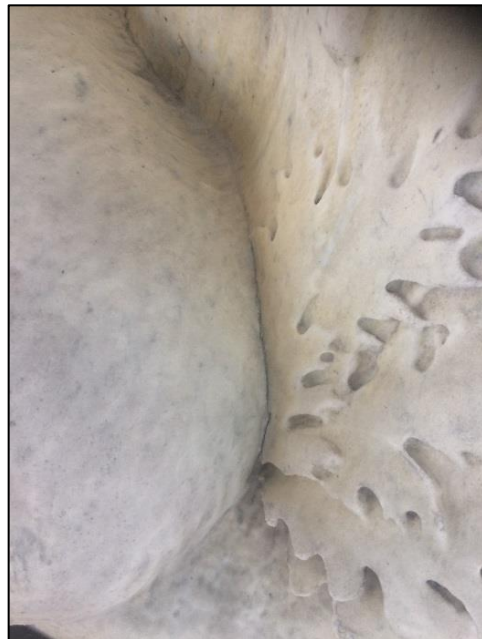
Between the dog's proper right side and the tree stump: 205mm

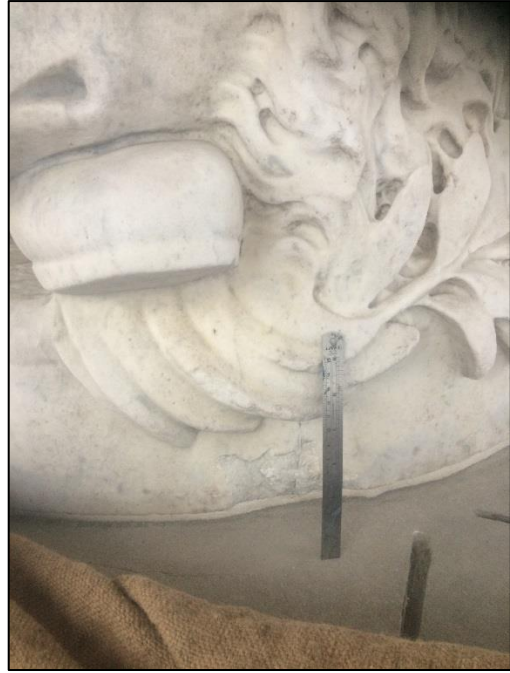
Perpendicular below Burn's proper right
foot: 100mm

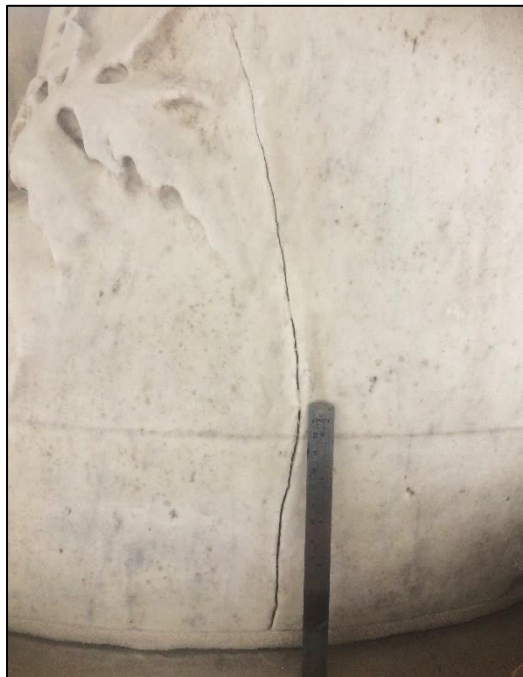
Perpendicular at the proper left side of the
thistle: 360mm
