GRACIELA
AINSWORTH

2nd November 2018

**FINAL CONSERVATION REPORT FOR THE MARBLE
ROBERT BURNS STATUE IN DUMFRIES TOWN CENTRE**

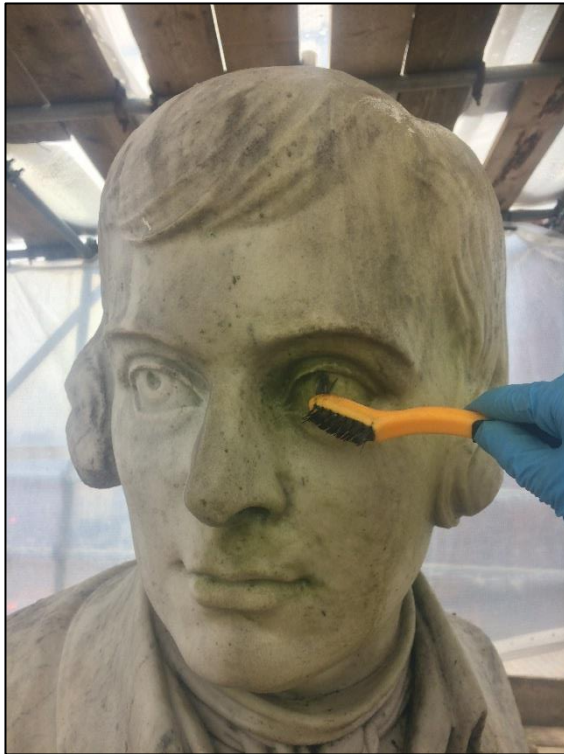
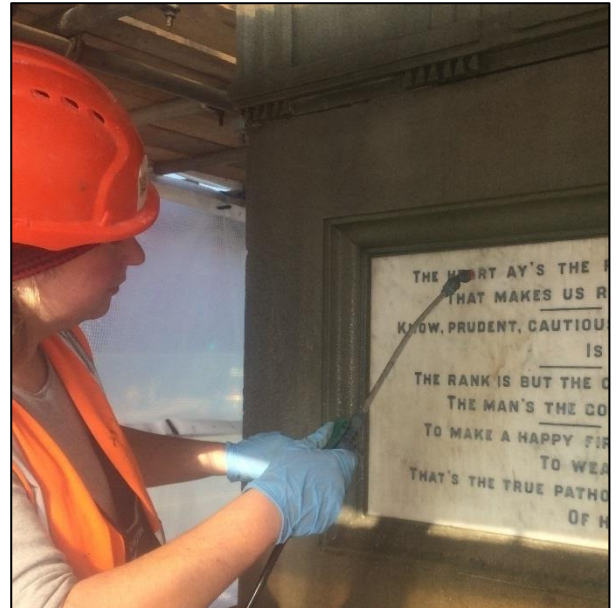
*Left: Brush cleaning with water and D/2 biocide
Right: Rinsing with clean water*

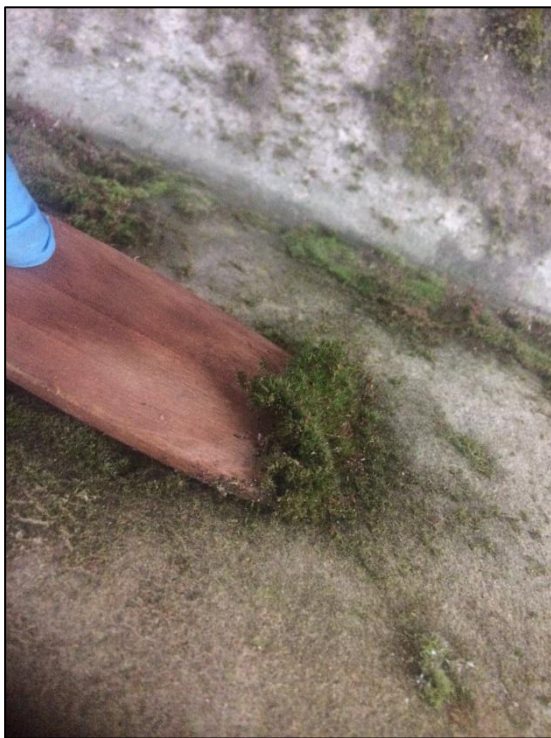
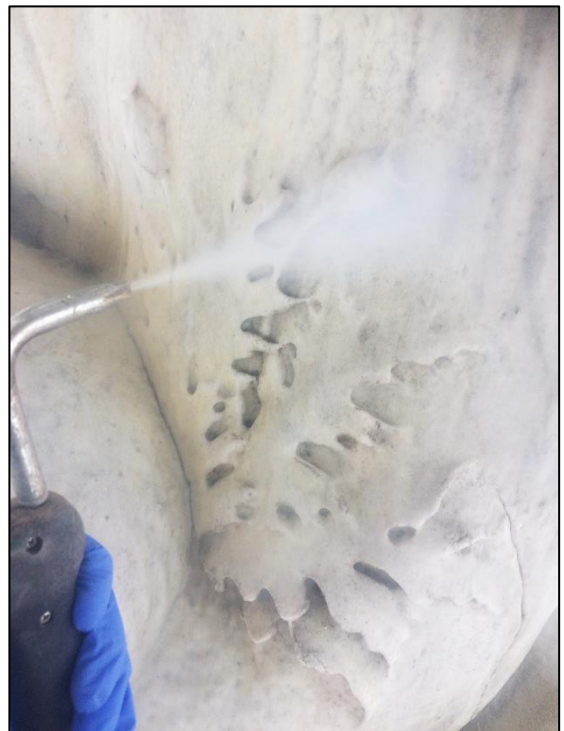
*Left: removing moss with wooden tools
Right: Steam cleaning more stubborn dirt deposits*

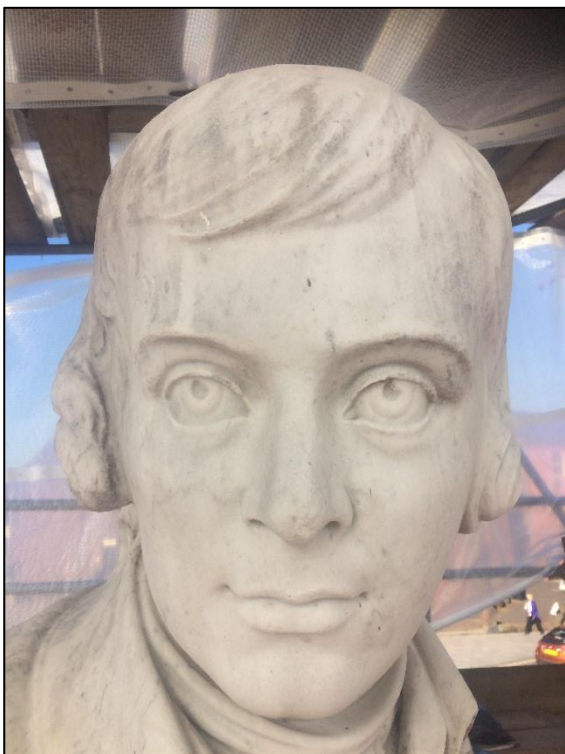
Left: During steam cleaning, Right: After steam cleaning

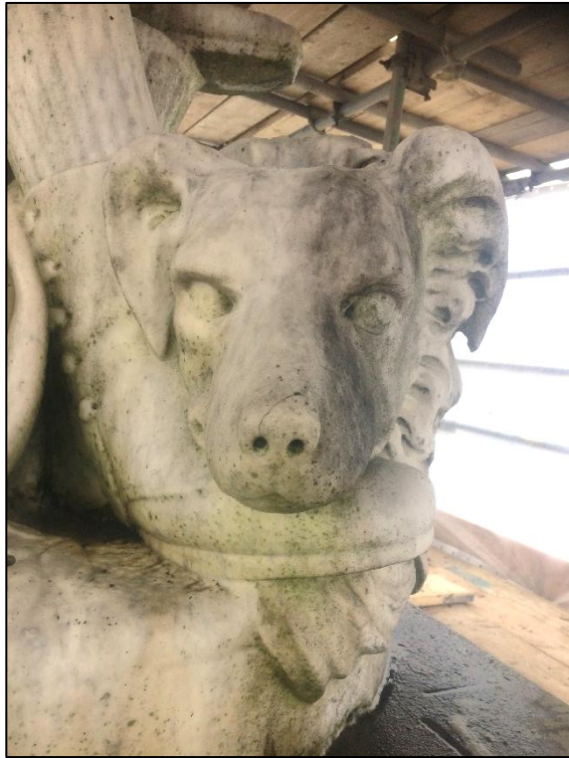
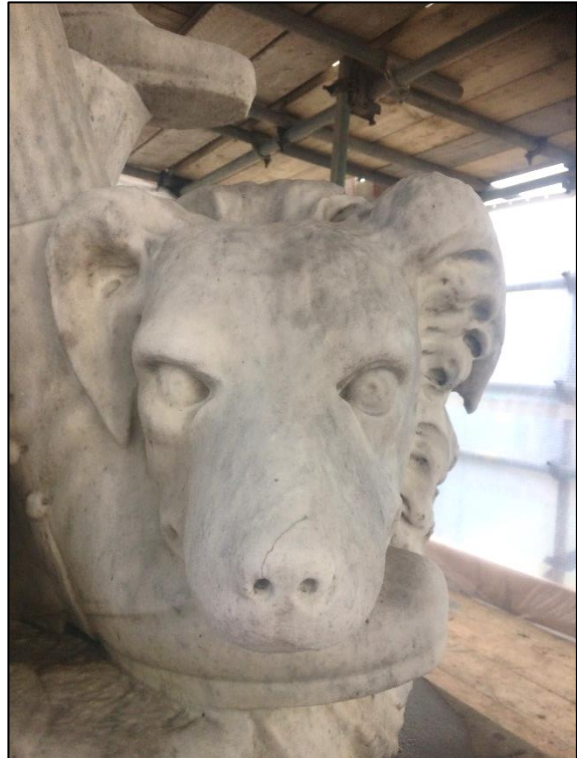
Left: During cleaning with water and D/2 biocide. Right: During steam clean

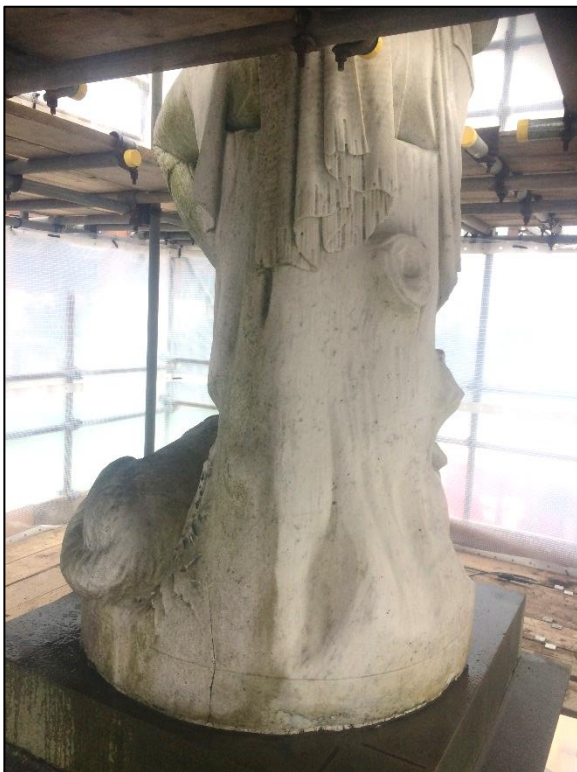
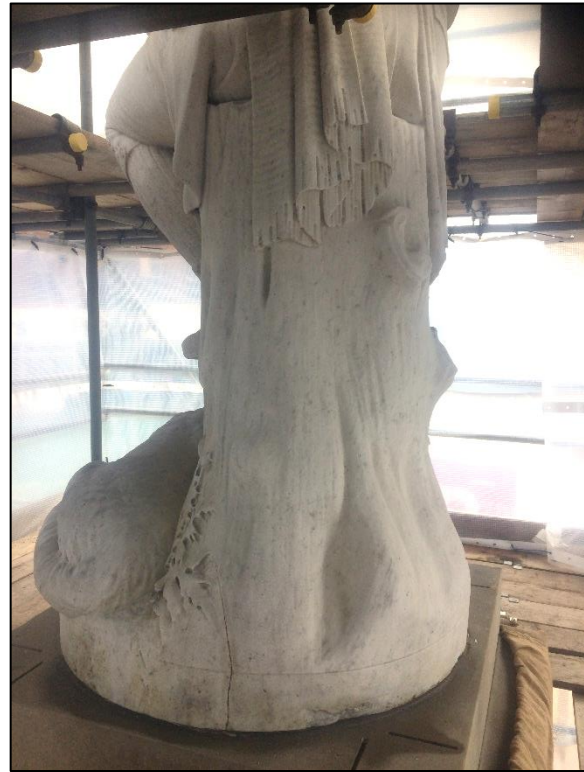
Left: During cleaning with water and D/2 biocide. Right: During steam cleaning

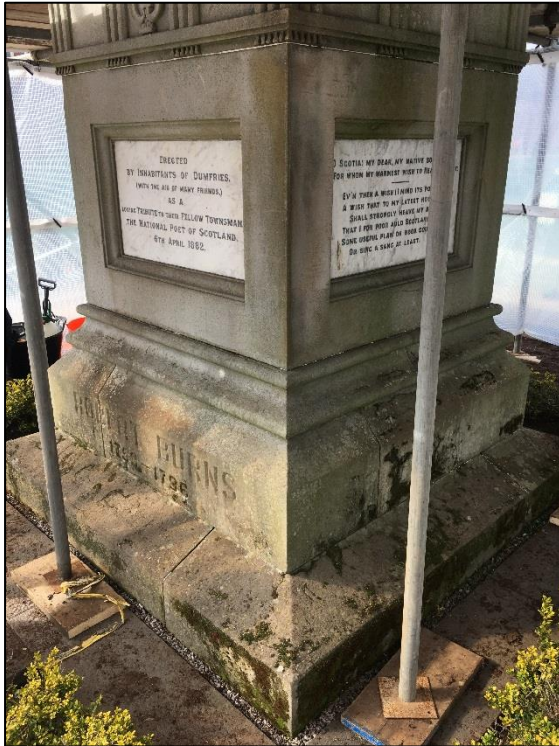
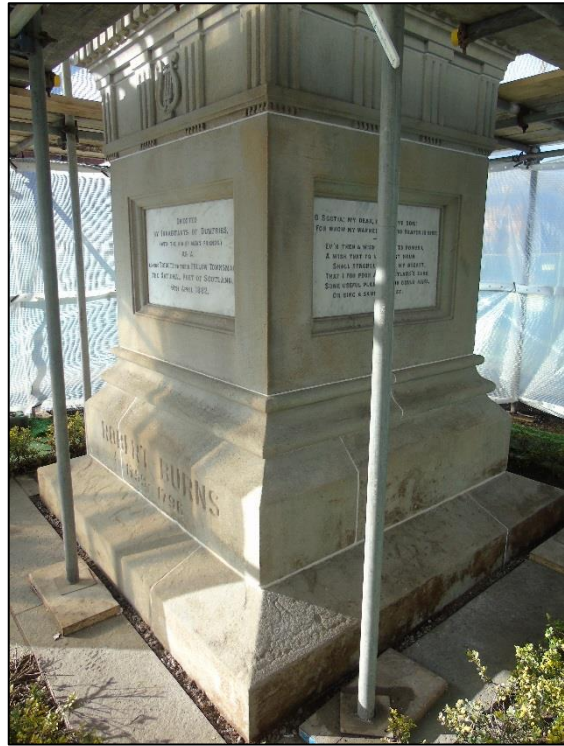
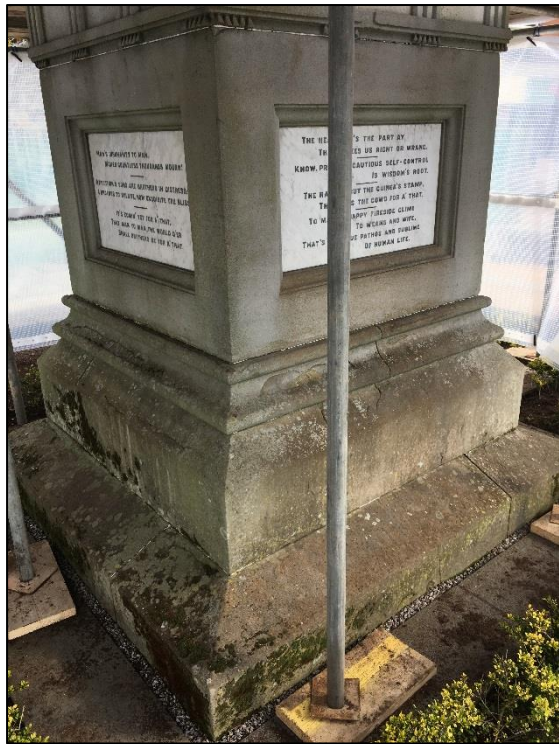
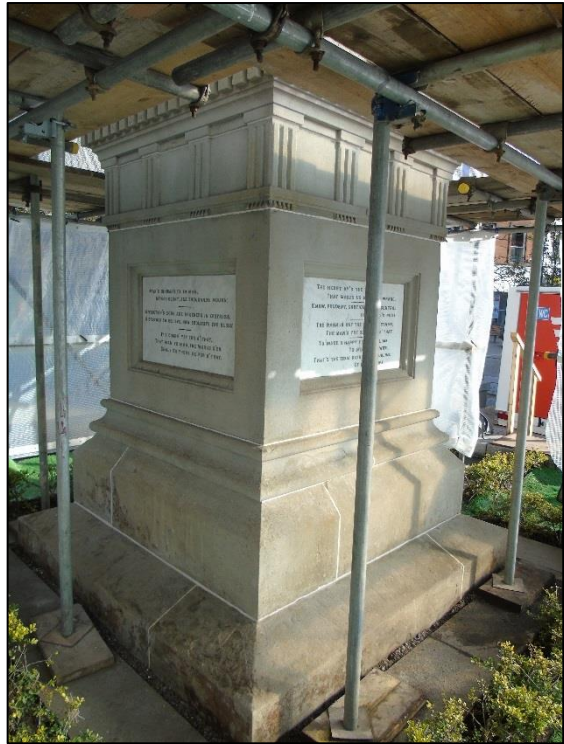
Before Conservation (left) and after Conservation (right)

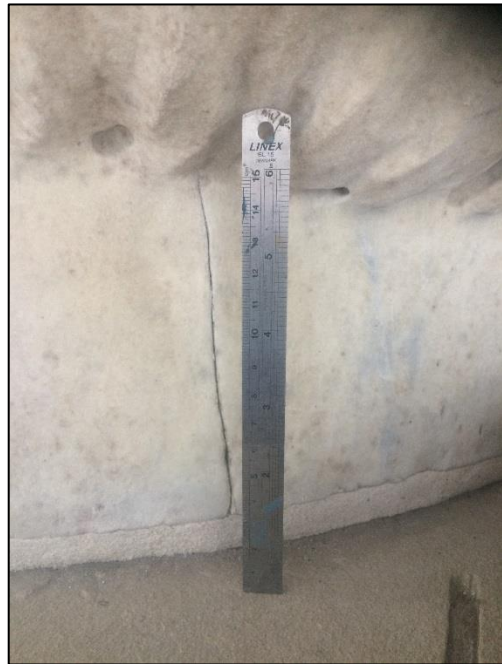
Perpendicular below the dog's tail: 140mm
